SMOKE TESTING OBSERVATION SUMMARY

Western Run Pilot Project - Baltimore Maryland

**BUREAU OF WATER AND WASTEWATER
SMOKE TEST INSPECTION FORM**

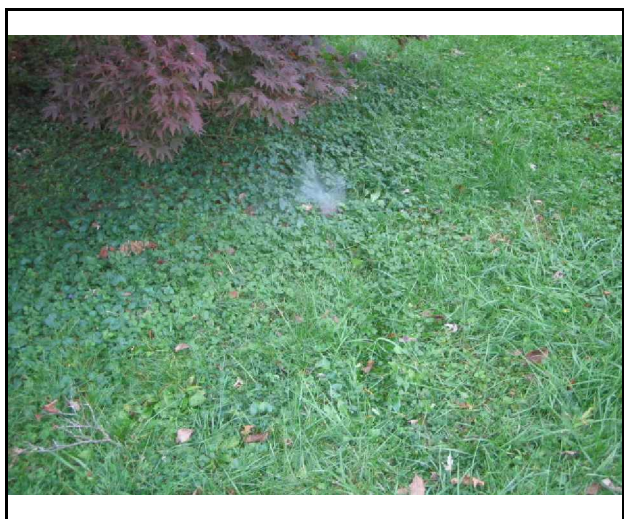
Photo No: 613

Unique Test ID	346	Date:	10/25/2004	MeterBasin:	01_WR29
Observer ID:	A	Crew:	T-3	Dye Test Recommended:	N
Defect No:	4	Setup No:	6	Priority CCTV:

House Number	3402	Street Prefix:		Street Name:	Olympia	Street Type:	AVE
Source Type:	04= Cleanout	Location:	7=Yard-Front	Severity:	3=Moderate		
Sector:	2=Private	Drainage Area:	10				
Comments:

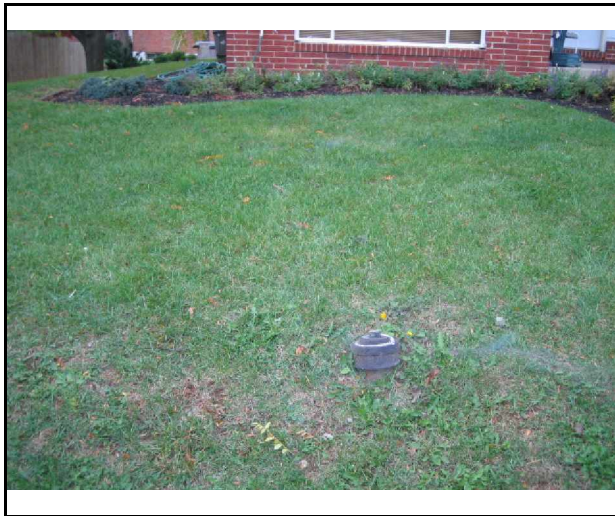
Unique Test ID	346	Date:	10/25/2004	MeterBasin:	01_WR29
Observer ID:	A	Crew:	T-3	Dye Test Recommended:	N
Defect No:	6	Setup No:	6	Priority CCTV:

House Number	3406	Street Prefix:		Street Name:	Olympia	Street Type:	AVE
Source Type:	04= Cleanout	Location:	7=Yard-Front	Severity:	2=Trace		
Sector:	2=Private	Drainage Area:	100				
Comments:

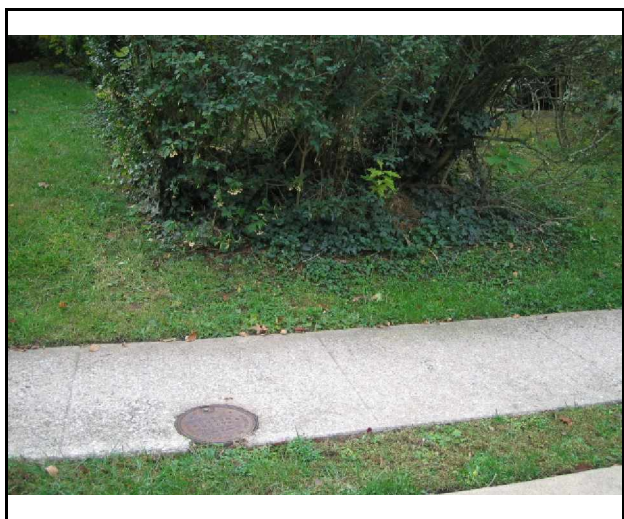
Unique Test ID	347	Date:	10/26/2004	MeterBasin:	01_WR19
Observer ID:	B	Crew:	T-2	Dye Test Recommended:	N
Defect No:	1	Setup No:	1	Priority CCTV:

House Number	5924	Street Prefix:		Street Name:	Cross Country	Street Type:	Blvd
Source Type:	18= Other	Location:	7=Yard-Front	Severity:	2=Trace		
Sector:	1=Public	Drainage Area:	16				
Comments:

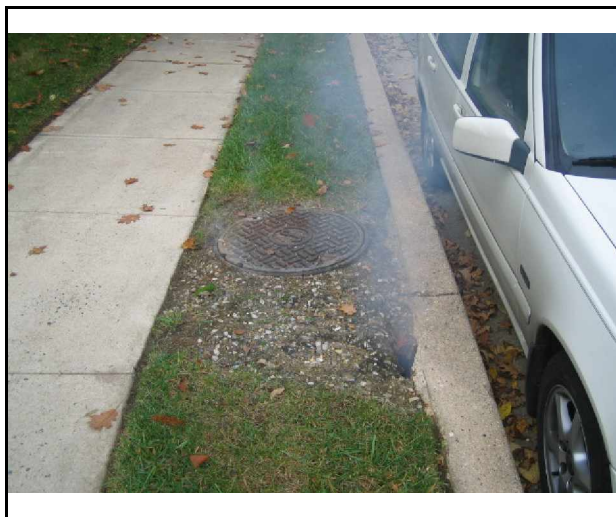
Unique Test ID	347	Date:	10/26/2004	MeterBasin:	
Observer ID:	B	Crew:	T-2	Dye Test Recommended:	N
Defect No:	3	Setup No:	1	Priority CCTV:	
House Number	5920	Street Prefix:		Street Name:	
				Cross Country	
				Blvd	
Source Type:	12= MH Frame Seal	Location:	7=Yard-Front	Severity:	4=Major
Sector:	1=Public	Drainage Area:	9		
Comments:	MH 1522440

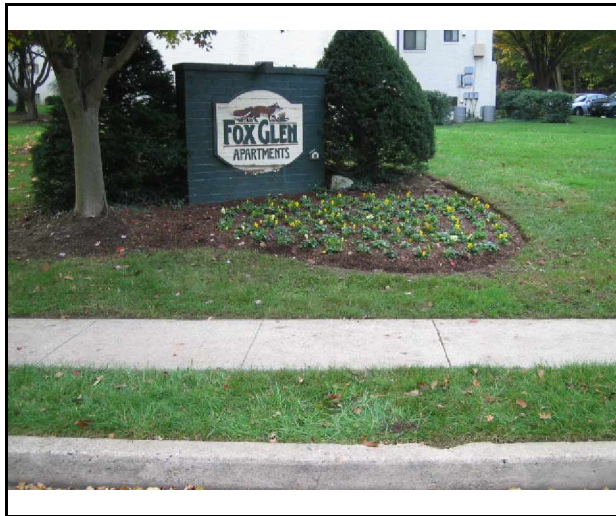
Unique Test ID	347	Date:	10/26/2004	MeterBasin:	
Observer ID:	B	Crew:	T-2	Dye Test Recommended:	N
Defect No:	4	Setup No:	1	Priority CCTV:

House Number	Street Prefix:	Street Name:	Street Type:		
5920		Cross Country	Blvd		
Source Type:	02= Service Line	Location:	7=Yard-Front	Severity:	2=Trace
Sector:	1=Public	Drainage Area:	4		
Comments:

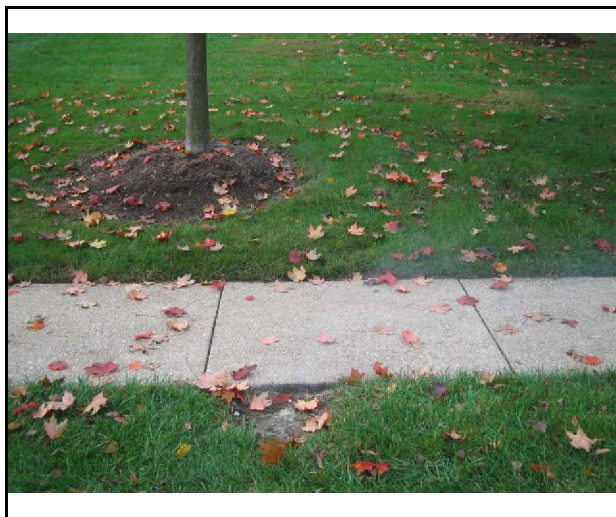
Unique Test ID	347	Date:	10/26/2004	MeterBasin:	
Observer ID:	B	Crew:	T-2	Dye Test Recommended:	N
Defect No:	5	Setup No:	1	Priority CCTV:

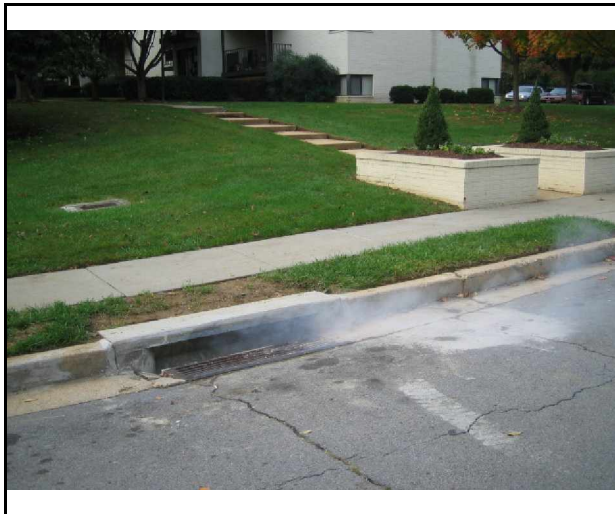
Unique Test ID	347	Date:	10/26/2004	MeterBasin:	01_WR19
Observer ID:	B	Crew:	T-2	Dye Test Recommended:	Y
Defect No:	6	Setup No:	1	Priority CCTV:

House Number	5914	Street Prefix:		Street Name:	Cross Country	Street Type:	Blvd
Source Type:	14= Catch Basin	Location:	6=Curb	Severity:	4=Major		
Sector:	1=Public	Drainage Area:	5000				
Comments:

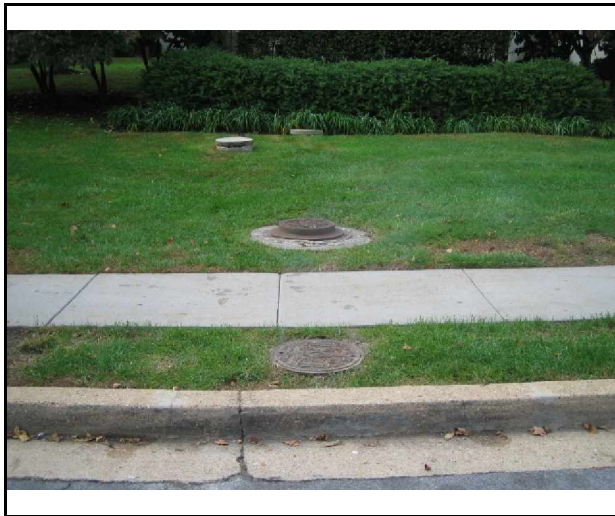
Unique Test ID	347	Date:	10/26/2004	MeterBasin:	
Observer ID:	B	Crew:	T-2	Dye Test Recommended:	N
Defect No:	7	Setup No:	1	Priority CCTV:

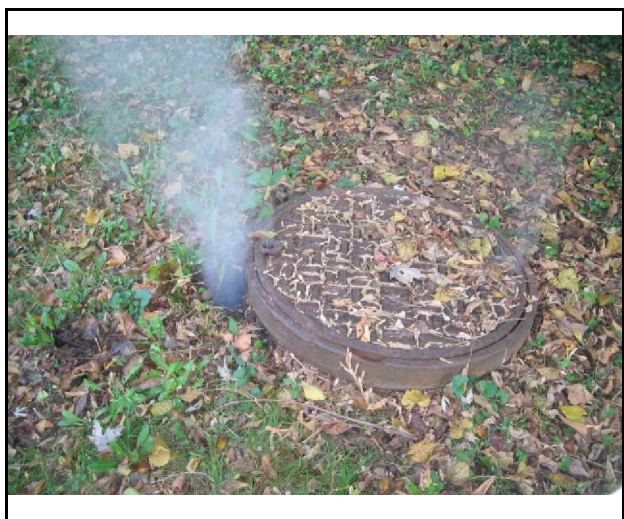
Unique Test ID	347	Date:	10/26/2004	MeterBasin:	
Observer ID:	B	Crew:	T-2	Dye Test Recommended:	N
Defect No:	8	Setup No:	1	Priority CCTV:

House Number	Street Prefix:	Street Name:	Street Type:		
5908		Cross Country	Blvd		
Source Type:	12= MH Frame Seal	Location:	11=Field	Severity:	4=Major
Sector:	1=Public	Drainage Area:	9		
Comments:	MH 01521300

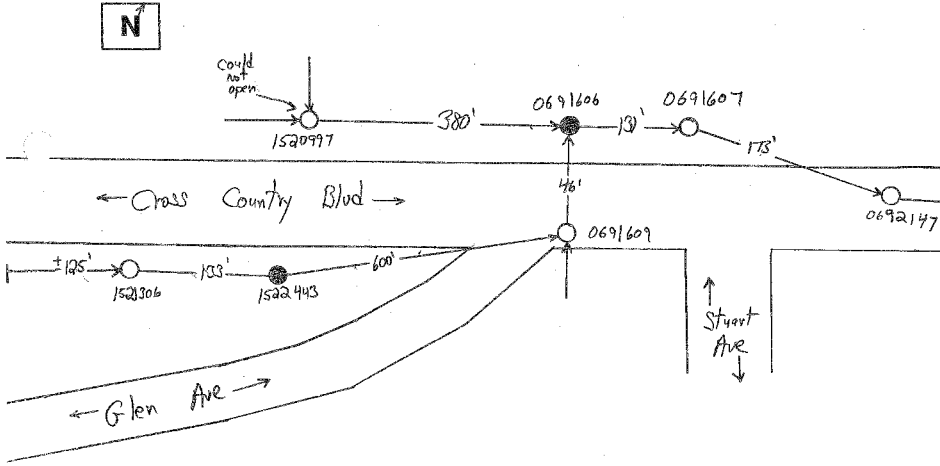
TEST LOCATION			
Project: WRPA	Sewershed: Jones Falls	Date: 10/26/04	Start Time: 1215
Crew: T2	Street Location: Cross Country Blvd	Number of Segments: 7	Test Length: 1588'
US MH: 1521306	DS MH: 0691607	# of Blowers: 1 2 3	Ground: (Dry) Moderate Wet
Plugged US: Y (N)	Plugged DS: Y (N)	Plugs Removed? Y (N) Recorder: Bob Blank Comments: —	
FIELD SKETCH (Show manholes and ID numbers, blower placement, source defect number, bldgs & street addresses, sandbag locations, etc.)

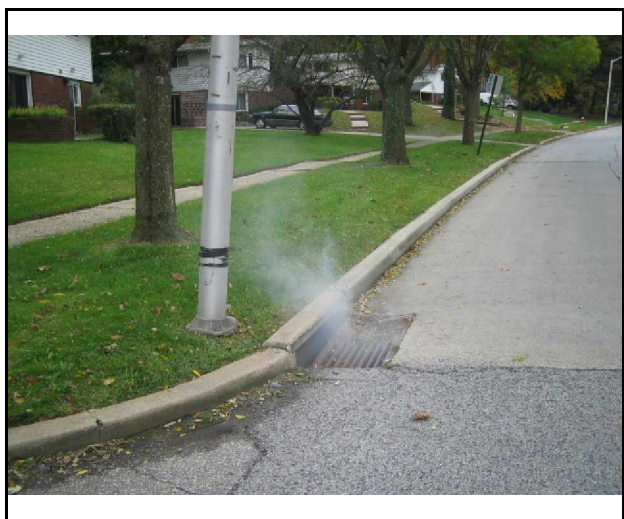
Unique Test ID	349	Date:	10/26/2004	MeterBasin:	01_WR18
Observer ID:	B	Crew:	T-2	Dye Test Recommended:	Y
Defect No:	1	Setup No:	3	Priority CCTV:

House Number	Street Prefix:	Street Name:	Street Type:
5820		Stuart	AVE
Source Type:	14= Catch Basin	Location:	9=Yard-Side
Sector:	1=Public	Drainage Area:	4000
Severity:	3=Moderate		
Comments:

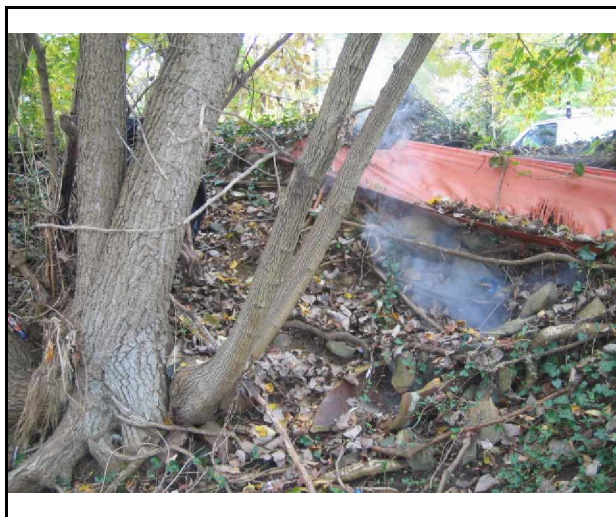
Unique Test ID	349	Date:	10/26/2004	MeterBasin:	01_WR18
Observer ID:	B	Crew:	T-2	Dye Test Recommended:	N
Defect No:	2	Setup No:	3	Priority CCTV:

Comments: immense drainage - overflow pipe plugged, but still smokes. SSO structure was field verified to be plugged. CCTV inspection and manhole inspection will be reviewed to assess potential sources of smoke.
